WHA 06H084-2

June 5, 2007

**WHA Test Report  
on  
Tekno Key Operated Pin Index Valve  
For  
BOC India Limited**

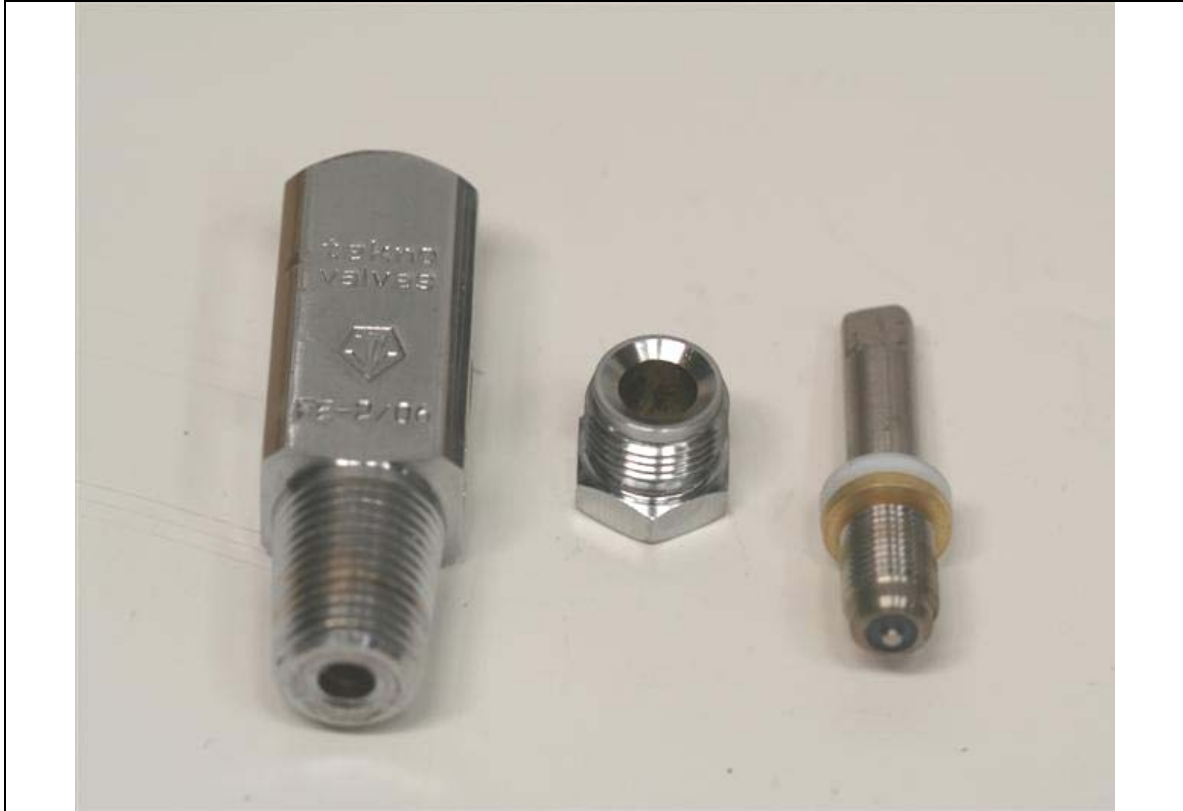
Pressure surge cycles were conducted on each of three test articles (TA-1A, TA-2A and TA-3A) according to the configurations listed above. Fifty (50) pneumatic impact cycles were performed in each configuration. No evidence of combustion was observed visually or audibly during the test. Post-test disassembly of each test article did not reveal evidence of ignition, scorching, melting, or deterioration of the valve seat or seals. Photographs of the post-test disassembled test articles and main seats for the three cylinder valves tested are attached as Photos 3 – 8.

**Photo 3: Post-test view of test article TA-1A after disassembly.**

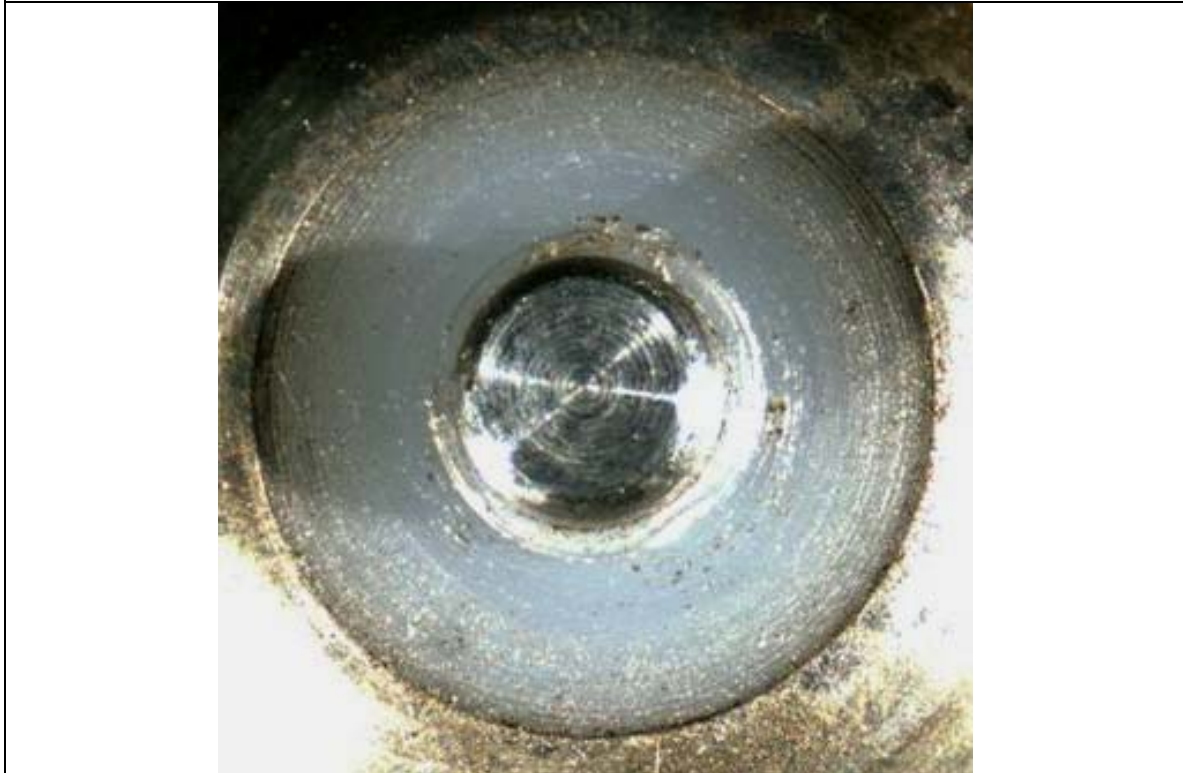
**Photo 4: Condition of the main seat after testing on test article TA-1A.**

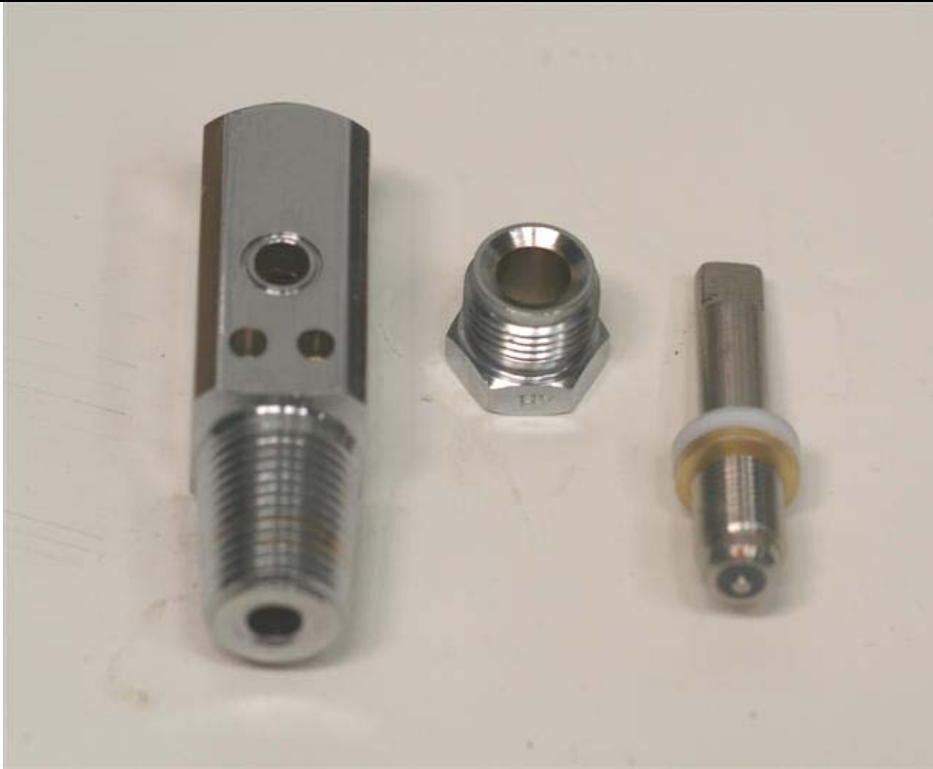
**Photo 5: Post-test view of test article TA-2A after disassembly.**

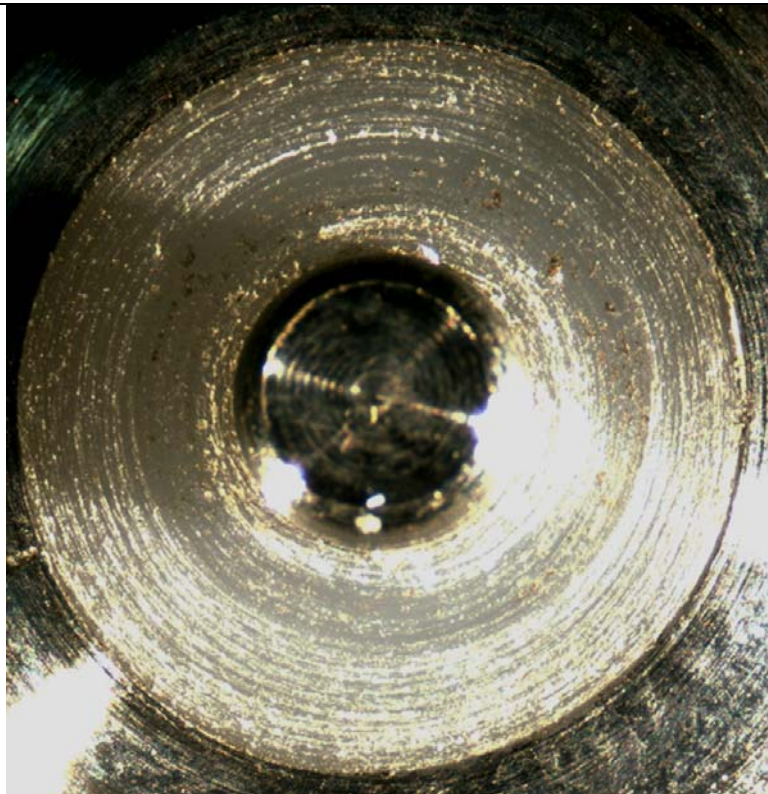
**Photo 6: Condition of the main seat after testing on test article TA-2A.**

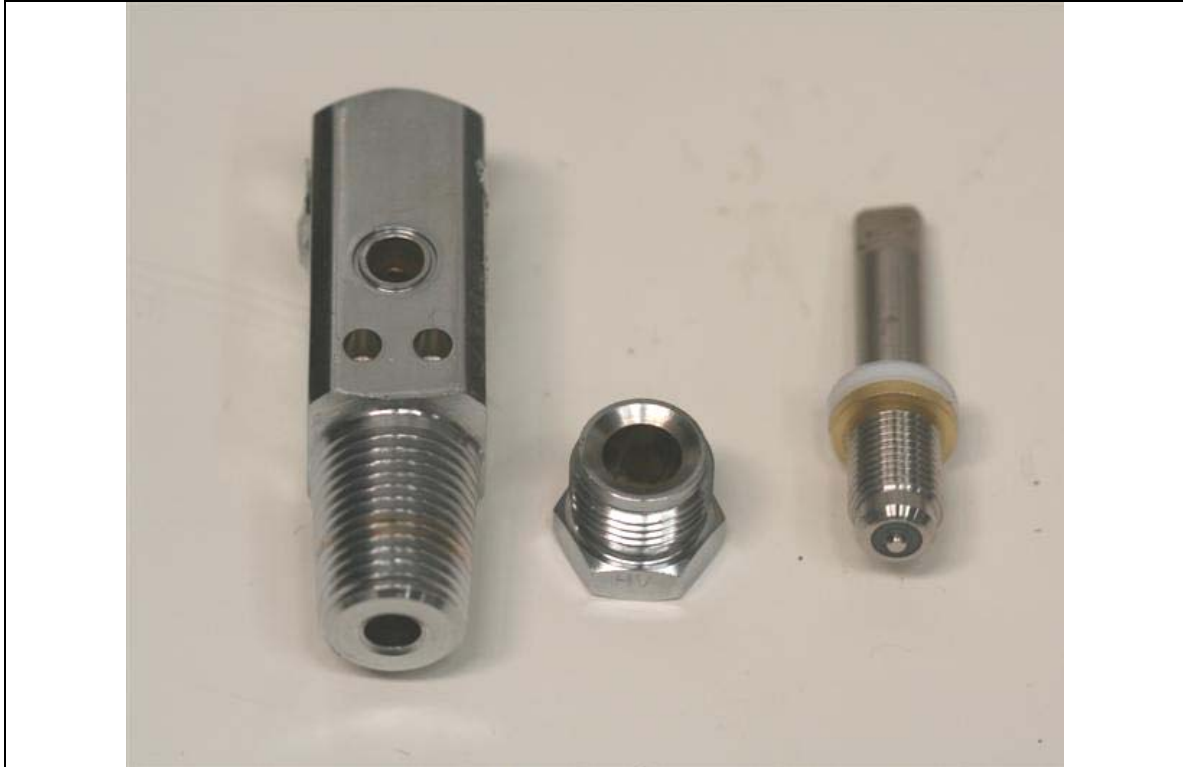
**Photo 7: Post-test view of test article TA-3A after disassembly.**

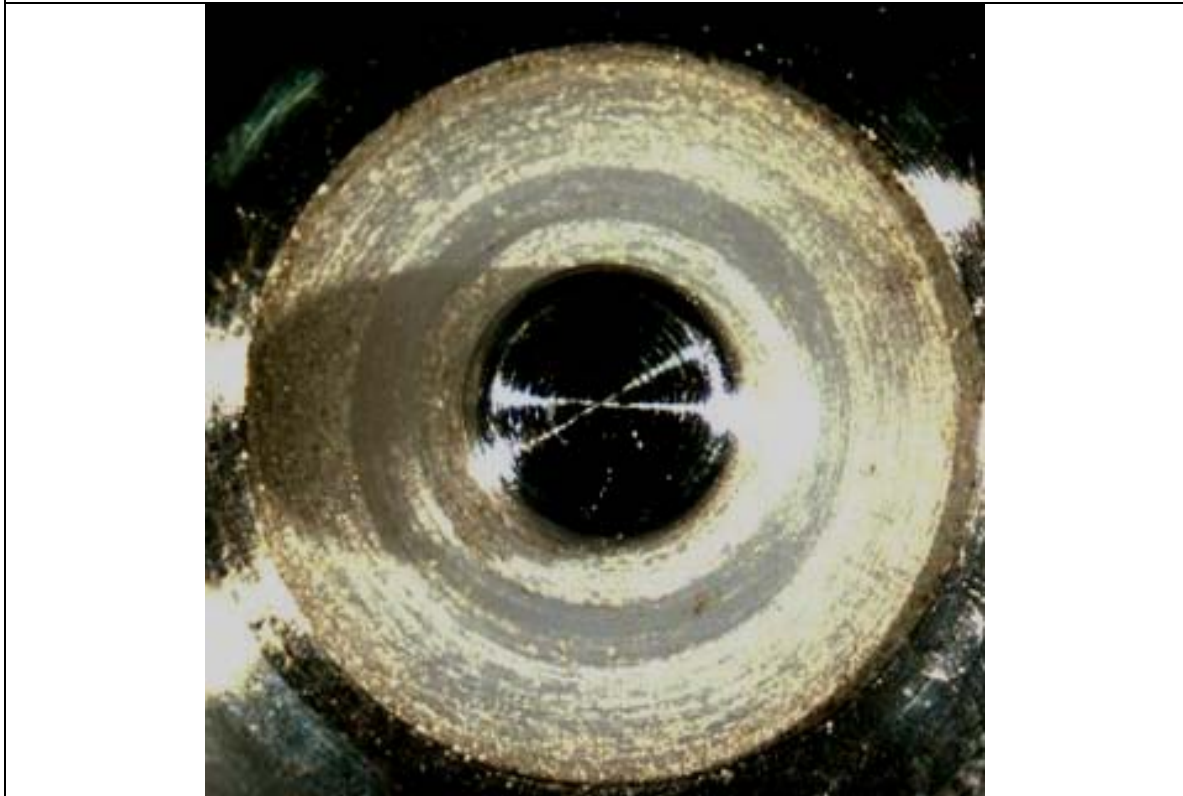
**Photo 8: Condition of the main seat after testing on test article TA-3A.**
