WHA 06H084-2

June 5, 2007

**WHA Test Report  
on  
Tekno Key Operated Pin Index Valve  
For  
BOC India Limited**

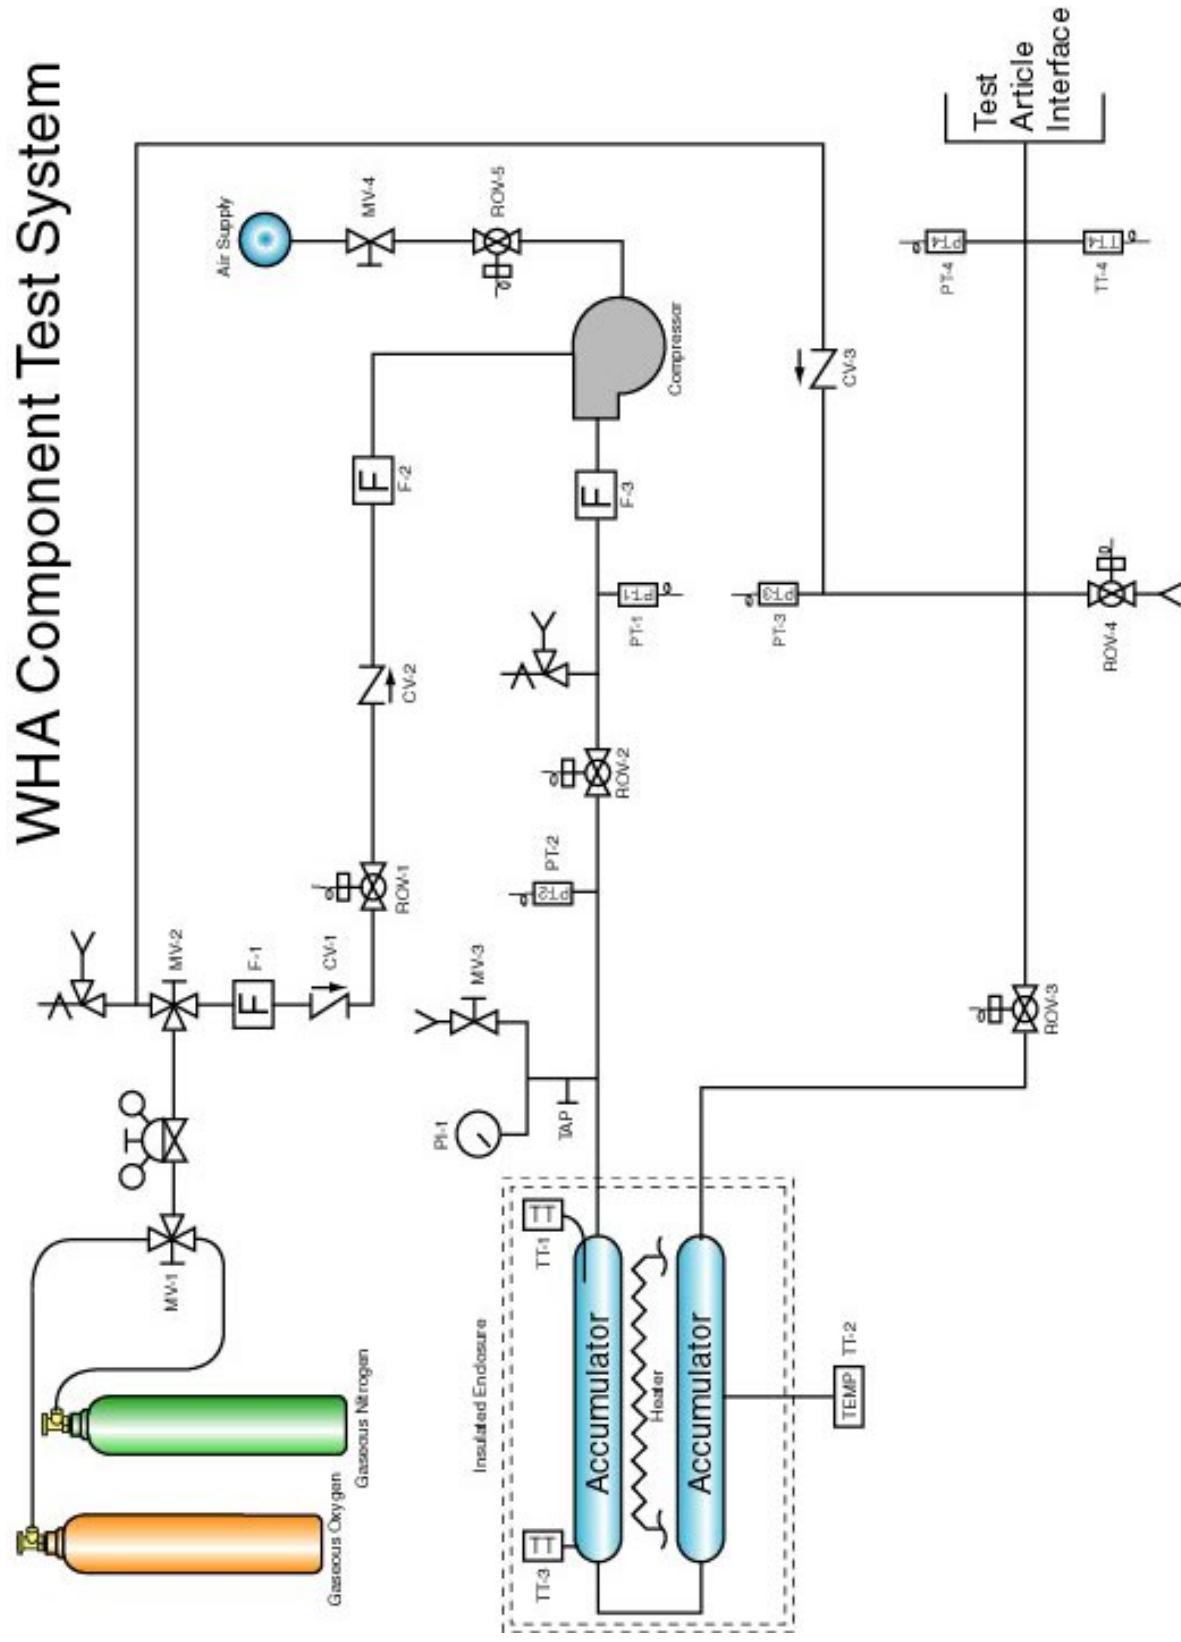
Figure 1: WHA Test System Schematic.

milliseconds was achieved at the end of a capped, 1-meter long, 5 mm inside-diameter tube. A test article was affixed to the WHA test system at an interface located a distance of one meter from the impact valve. A vent valve to relieve pressure in the test system was located between the WHA impact valve and the test article. A high frequency response pressure transducer was provided to ensure that the required test article pressurization rate was achieved for each cycle. Pressurization rates were monitored and recorded during each pressure shock. An oxygen supply was provided to replenish the test system accumulator between test cycles. The test was performed under computer control and data was recorded digitally. Figure 1 depicts a schematic representation of the WHA pneumatic impact test system.

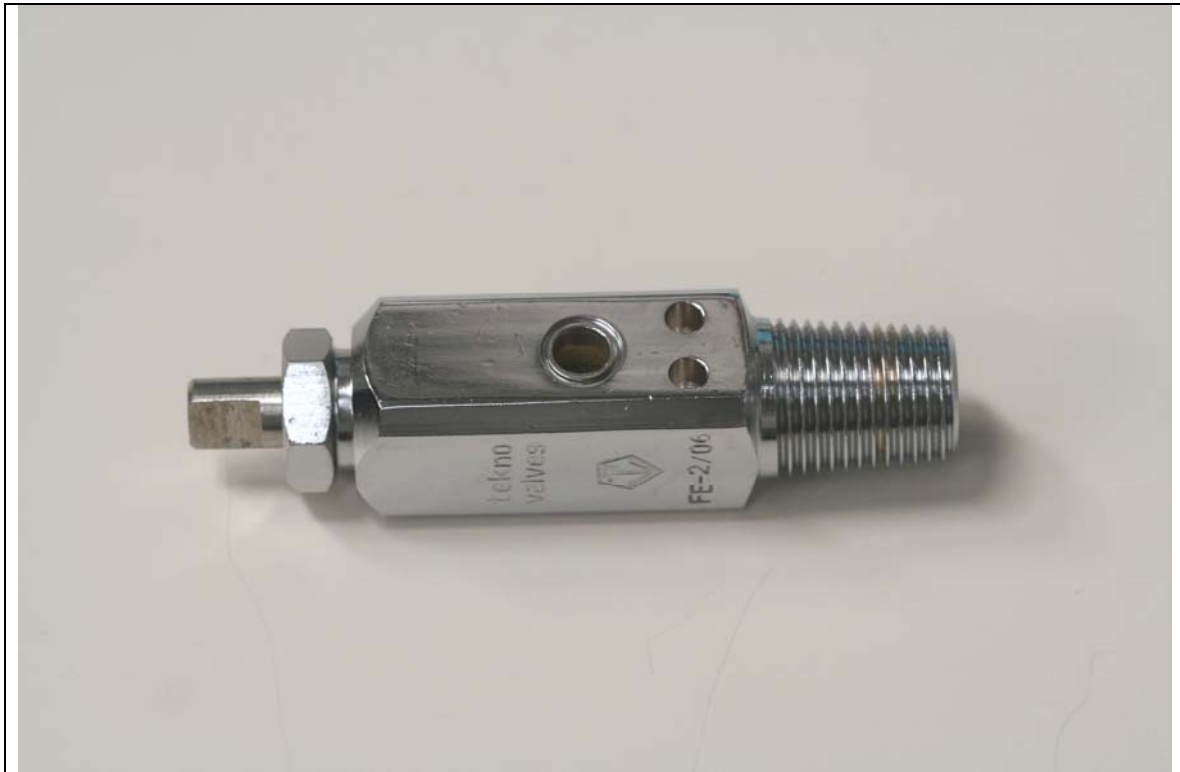
The test articles consisted of brass bodied cylinder valves equipped with a rotating seat, “plug-style”, operating mechanism. A typical valve in its “as received” condition is attached as Photo 1. Three (3) test articles (TA-1A, TA-2A, and TA-3A) were tested according to the test standard indicated above.

**Photo 1: Typical test article in its “as received” condition.**

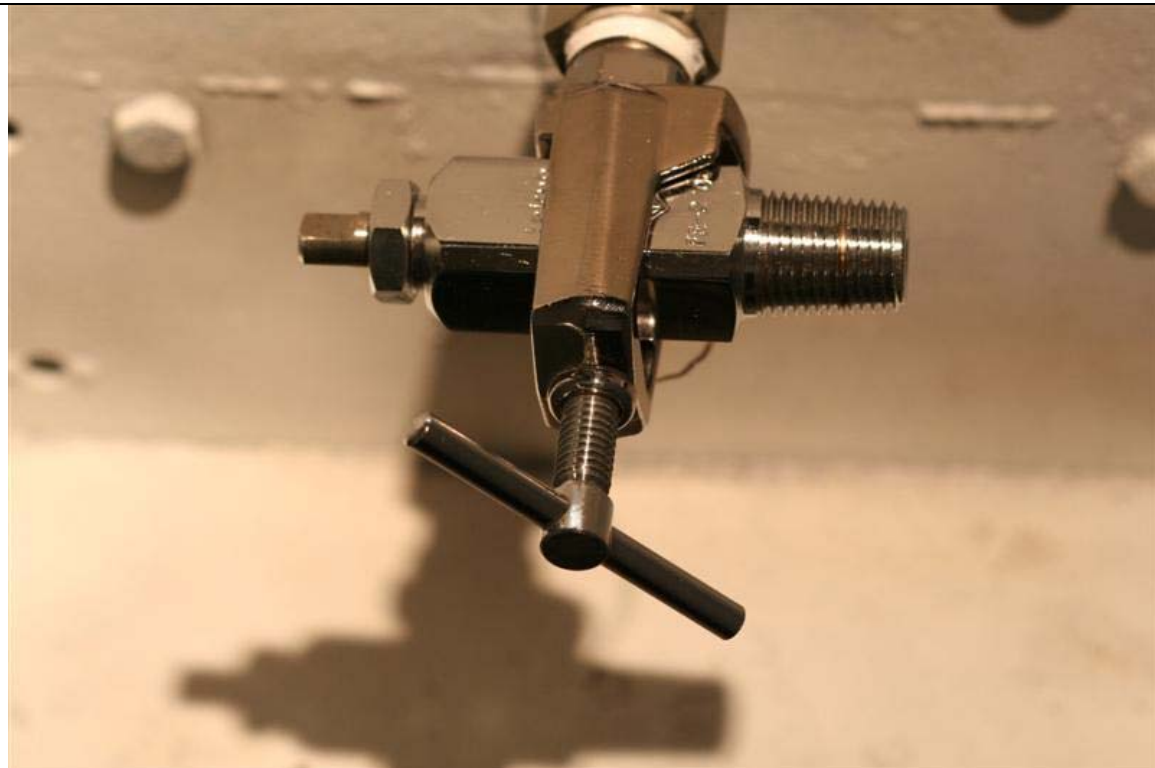
Each valve was tested in two configurations within the standard WHA pneumatic impact test system<sup>1</sup>. Photo 2 shows a typical test article as installed on the WHA test system.

**Photo 2: Typical test article as installed on the WHA test system.**
